MH17

The Open Source Investigation
Two Years Later

by and for citizen investigative journalists

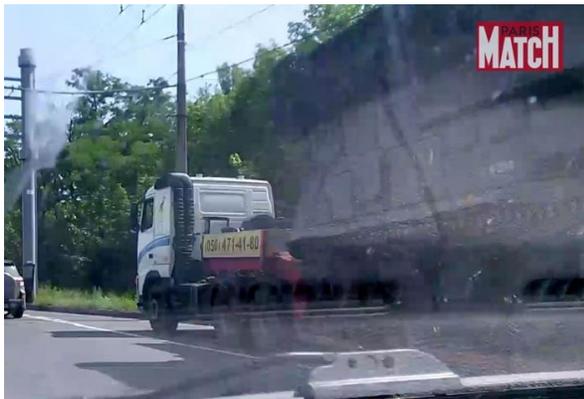
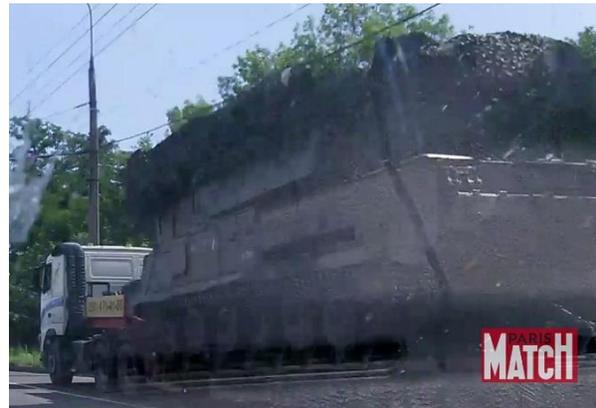
Figure 2: The first Paris Match photograph from Donetsk

Figure 3: The second Paris Match photograph from Donetsk

The French tabloid magazine *Paris Match* has shared two images^{13 14} showing the Buk in Donetsk. In the first image, a gray 2010 Toyota RAV4—matching the witness account from the “Donetsk is Ukraine!” VK group—is seen ahead of a Volvo truck hauling a Buk-M1 TELAR (Transporter Erector Launcher and Radar). In the second image, various details of the Buk missile launcher are clearer, including the netting above the four mounted missiles.

The exact time that these images were captured is unclear, but were certainly taken between 9:30am and 11:00am. *Paris Match* stated that the photograph was taken “about 11am” on the morning of July 17th.¹⁵ There is far less uncertainty about the location of the images. The visible landmarks in the photograph reveal the exact location of the Volvo truck and Buk as near the Motel roundabout in eastern Donetsk.

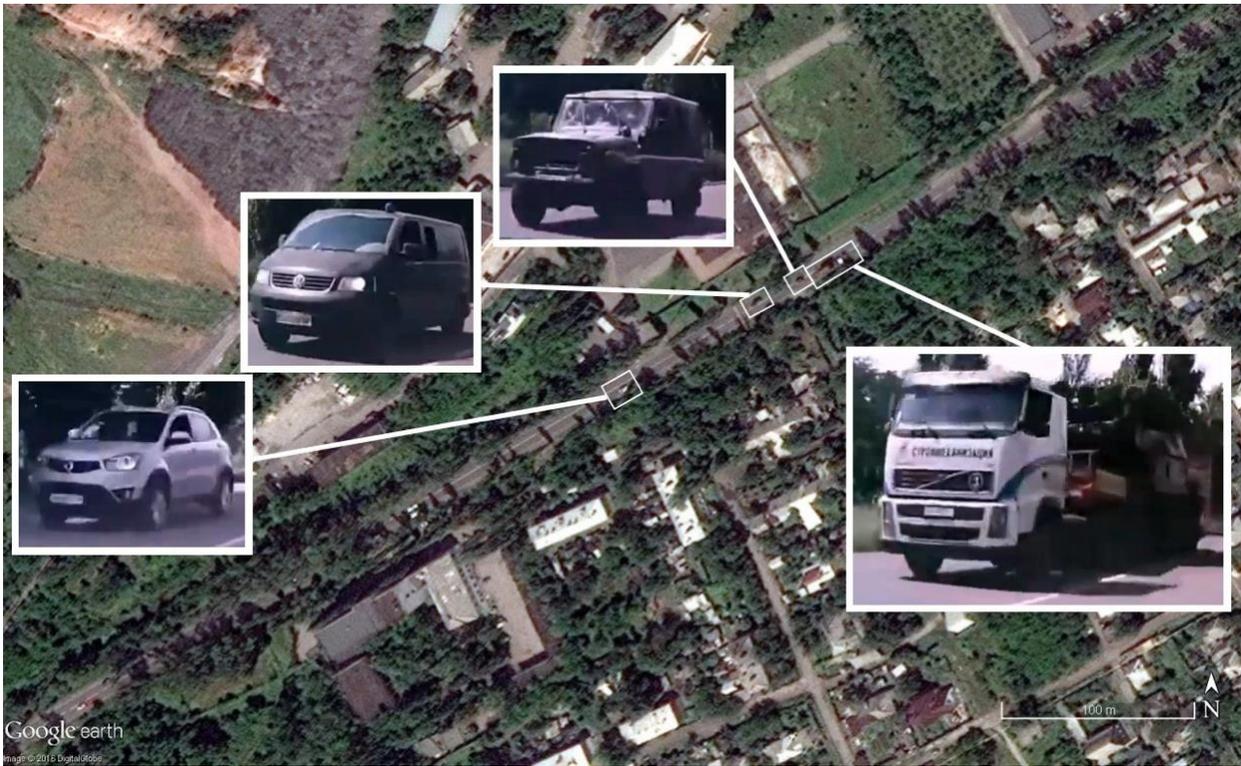
Figure 5: Positions of vehicles in the Makiivka video from satellite imagery dated July 17 2014 (Source - Google Earth/Digital Globe)

On June 22, 2016, Google published satellite imagery from Digital Globe of the area captured on July 17th 2014, showing the truck moving through Makiivka close to the location shown in the video.¹⁷ Based on information from Digital Globe, the satellite image was captured at 11:08am local time.

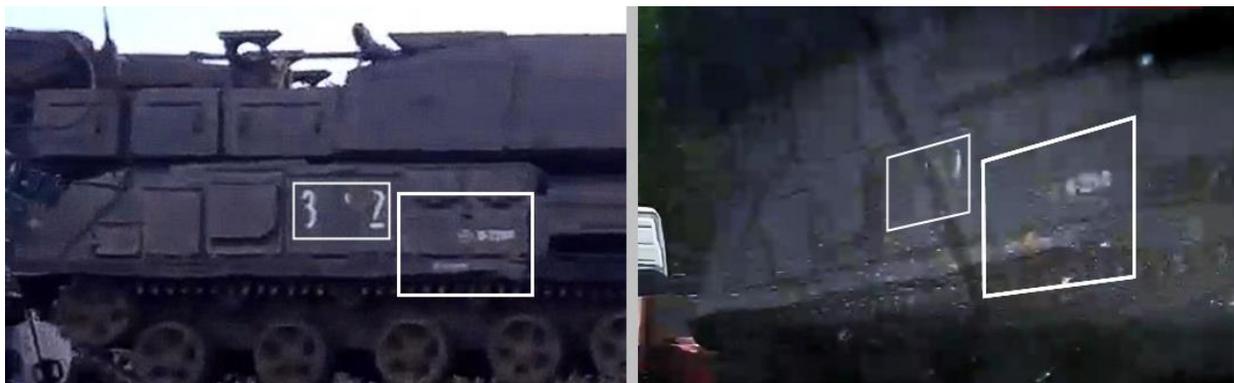
Figure 21: Markings on Buk 3x2 filmed in Russia in June 2014 (left) and markings from the Buk in the Donetsk Paris Match photographs (right)

This Buk has many similarities with the one photographed and filmed in Ukraine on the day of the MH17 downing. This Buk seen in Russia was dubbed “3x2” due to an obscured number on the side of the vehicle. Since early investigations, we have been able to determine that this Buk was originally numbered 332 after comparing the various characteristics from photographs and videos going back to 2010.⁶² The remaining fragments of the numbers of the Buk seen in the Paris Match images, as well as the railway transport markings, center of gravity mark, white paint on the rubber side skirt, and other features were in the exact same positions.⁶³

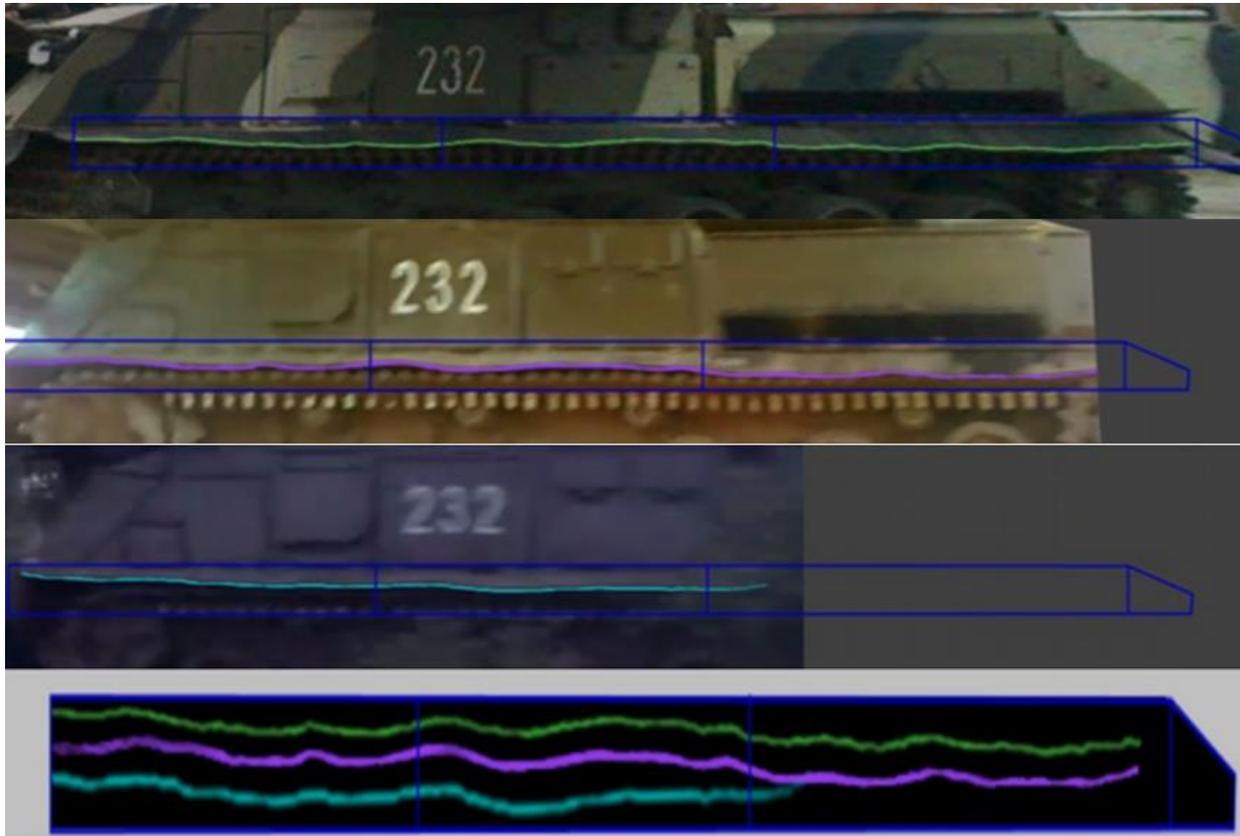
Figure 23: Side skirt comparison of Russian Buk 232 over a period of a year

sustain damage over time, creating a unique “fingerprint.” Comparing these side skirt damage patterns, or “fingerprints,” we can identify and match Buk missile launchers with one another. For example, below is a comparison of the side skirt fingerprints of a Russian Buk numbered 232. All three photographs were taken in the same year.

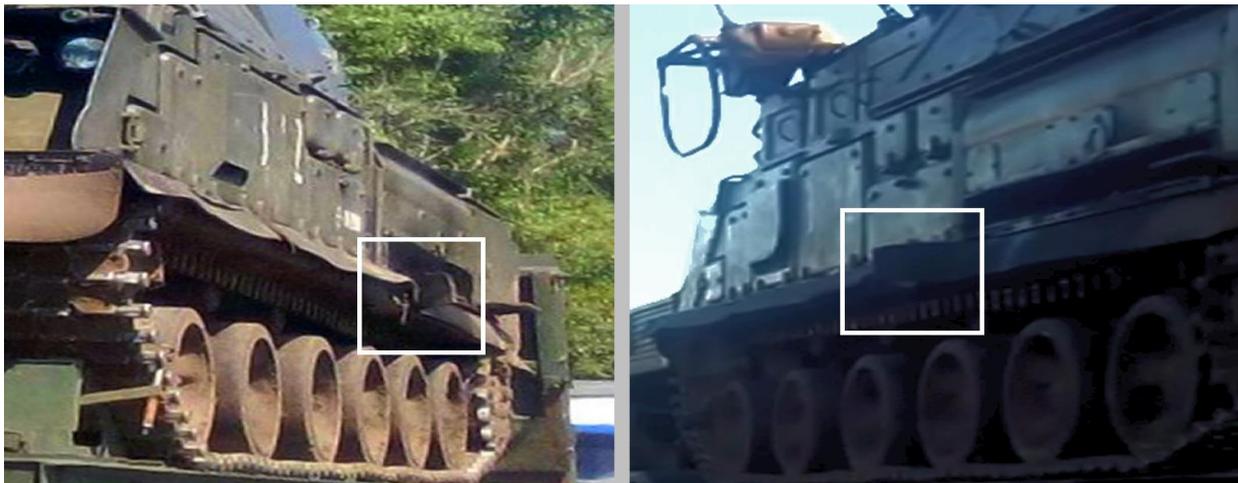
Figure 25: Damage to the side skirt visible on Buk 3x2

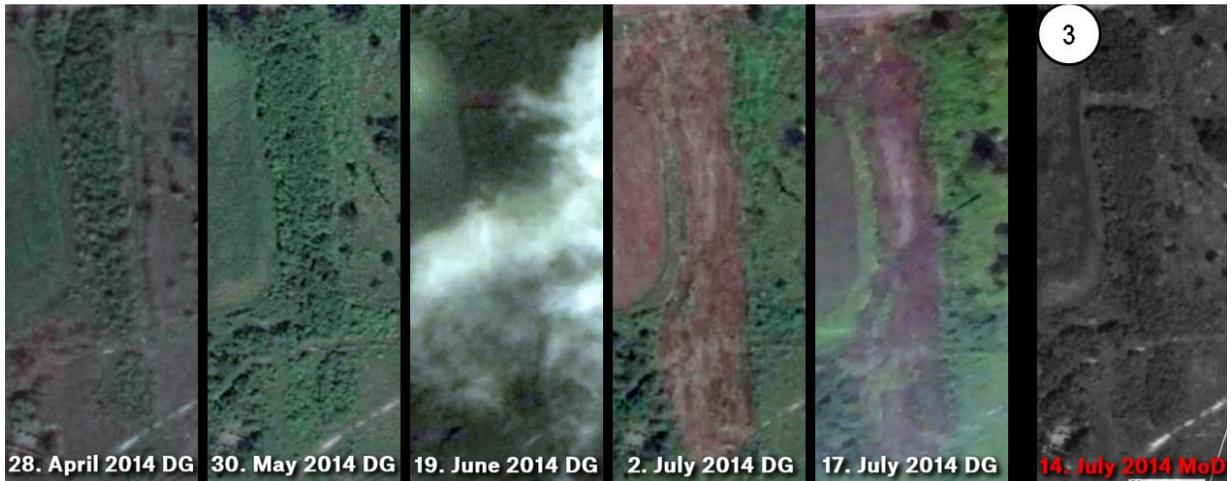
Figure 33: Comparison of missing vegetation on different dates to Russian Defence Ministry satellite imagery

Historical satellite imagery of the same location from July 2 and 21 of the same area on Google Earth confirms that the vegetation had been cleared weeks before July 17. Patches of worn-away grass visible in the Russian Defence Ministry imagery were also absent in the Google Earth July 17 imagery.

But, as with some of the other discrepancies between the images, the patches of missing grass were visible in earlier historical imagery on Google Earth, clearly showing the Russian Defence Ministry images were from weeks before MH17 was shot down.

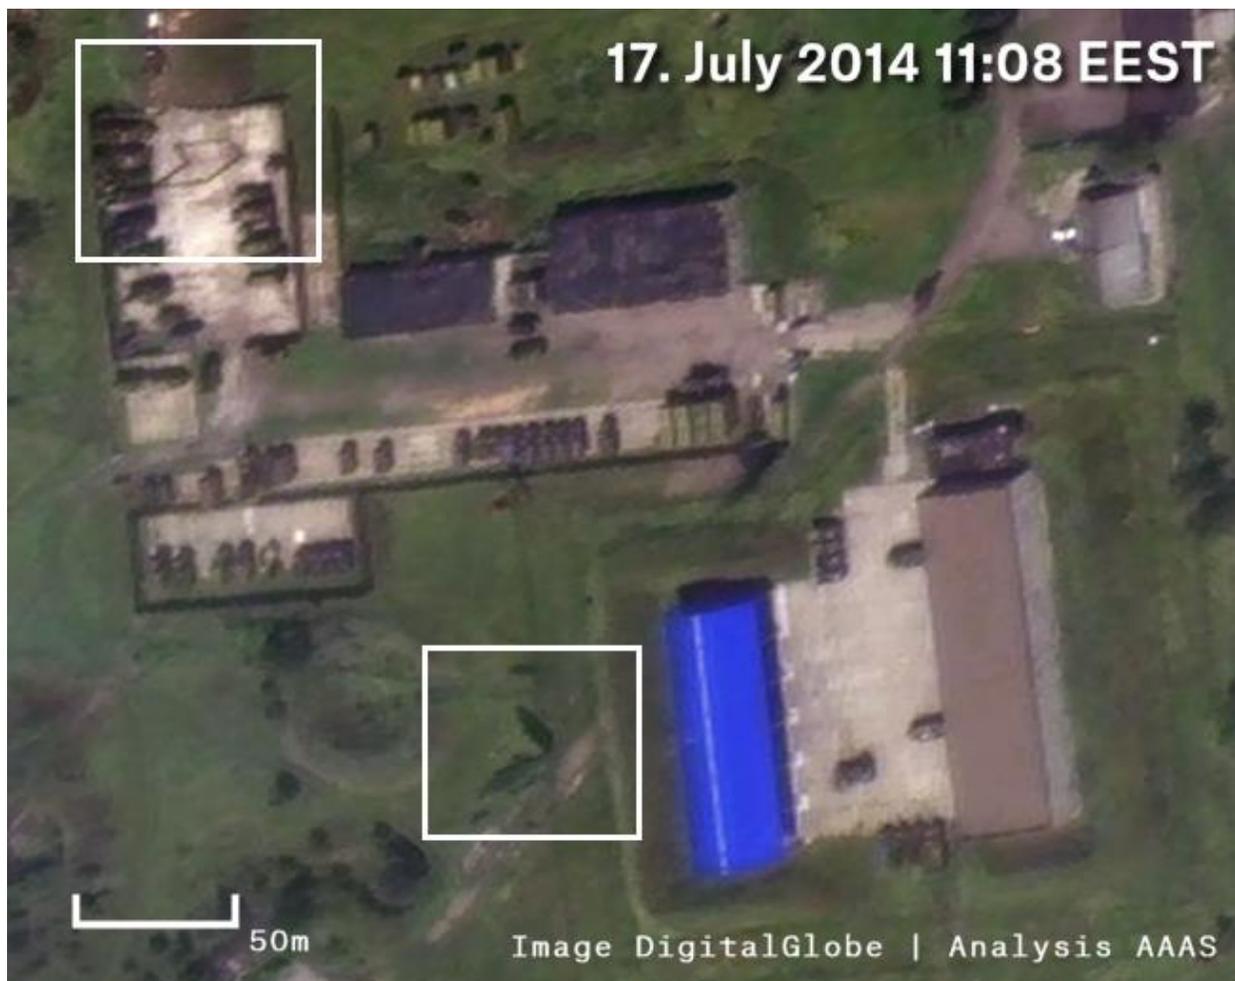
Figure 36: Image highlighting the object used to measure solar azimuth

AAAS were provided with Digital Globe images of the Ukrainian A1428 military base on June 7 2014 and July 17 2014.⁷⁸ The AAAS analysts applied shadow analysis techniques to examine the Digital Globe and Russian Defence Ministry imagery of the A1428 military base, with the first step being to determine how accurately the solar azimuth and elevation could be derived from the features present in each image. Three points were identified that were visible in Russian Defence Ministry Imagery and the Digital Globe imagery, two poles on an archway, and a tall tree located southeast of the archway.

First examining the June 7 2014 and July 17 2014 Digital Globe images analysts found the solar azimuth in the metadata and NOAA solar azimuth were identical, with the mean solar azimuth deviating from between 0.20 and 1.85 degrees on the archway's poles, and 3.15 to 4.80 on the tree. The great deviation was stated to be likely due to the trees irregular shape reducing the accuracy of the measurement.

The July 14 2014 Russian Defence Ministry image of the A1428 base was found to have a mean azimuth deviation of 15.91 and 11.41 on each pole, and 7.41 on the tree, while the July 17 2014 image, where only the tree is visible, had deviation of 9.76.
